Antibiofilm coated implants in the prevention and treatment of periprosthetic infection: a case series

- Bactiguard coating
- Orthopaedic prosthetic infection
- Noble metal nanoparticle coating

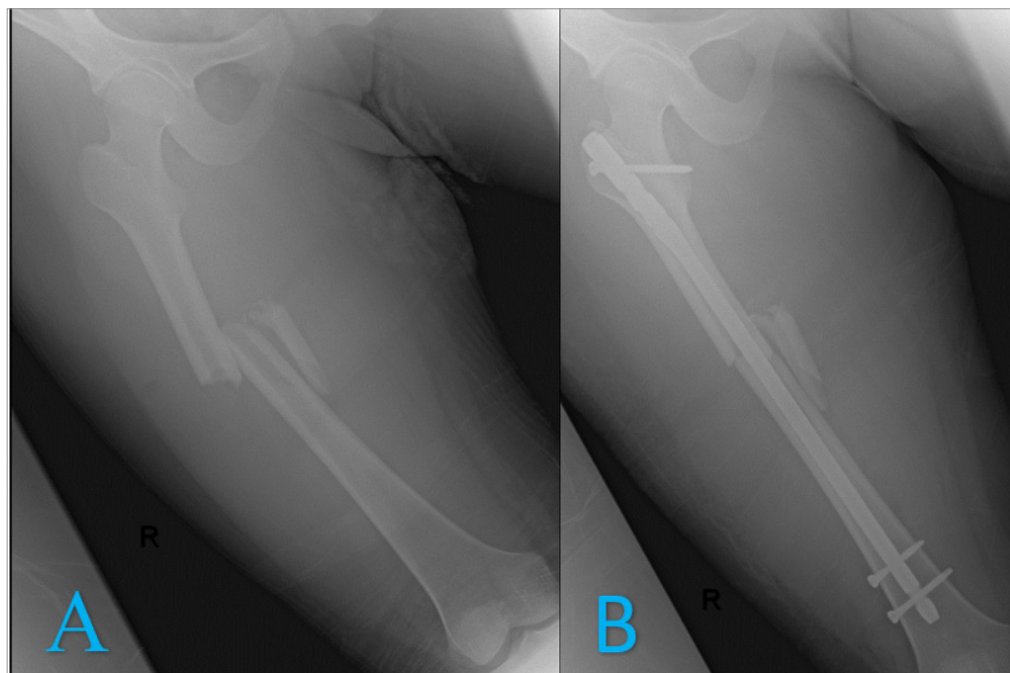
Figure 1. Radiograph of right femur anteroposterior view preoperative (A). Radiograph of right femur anteroposterior postoperative (B)

A 16-year-old girl with no known medical illness had an alleged Motor vehicle accident. She was unable to walk due to severe pain and deformity of the right thigh following the incident. She presented within three hours of the accident with a right open midshaft femur fracture (*Figure 1*). A lacerated puncture wound measuring 1x1 cm was seen over the proximal third of the right thigh. However, the neurovascular examination revealed normal findings.

As the patient presented within three hours, we proceeded with early definitive care, a definitive treatment for the long bones within 24 hours to 48 hours of initial trauma, to help the patient gain early mobility. After obtaining informed consent we went ahead with wound debridement and intramedullary nailing of the femur with an antibiofilm coated implant. The

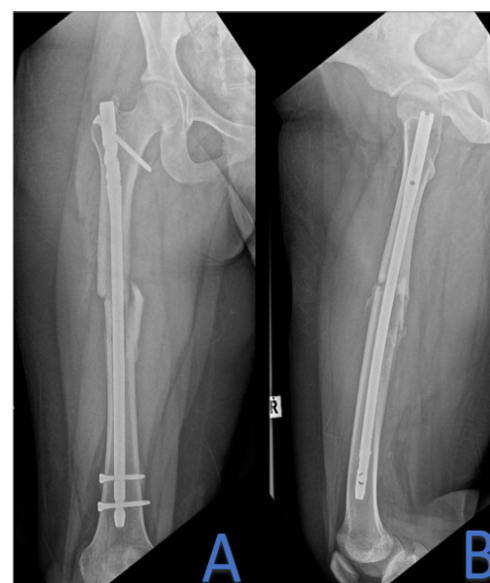
Figure 2. Radiograph of right femur anteroposterior (A) and lateral (B) view six months postoperatively

Postoperatively the patient was well with no signs of early infections at 6 months (Figure 2). The patient was able to walk without aid in 1-year follow-up with no signs of implant loosening or infection.

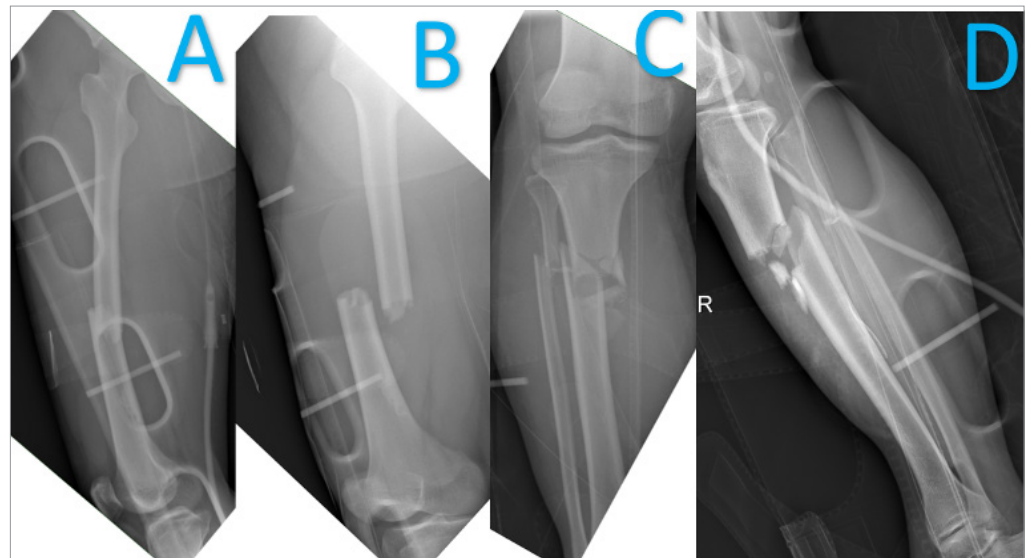
Figure 3. Radiograph of right femur anteroposterior (A) and lateral view (B) post trauma. Radiograph of right Tibia/Fibula anteroposterior (C) and lateral view (D) post trauma

A 16-year-old male presented following an alleged motor vehicle accident with a closed displaced right midshaft femur fracture and closed right comminuted proximal third tibia fibula fracture (Figure 3). We proceeded with cross knee external fixation as the

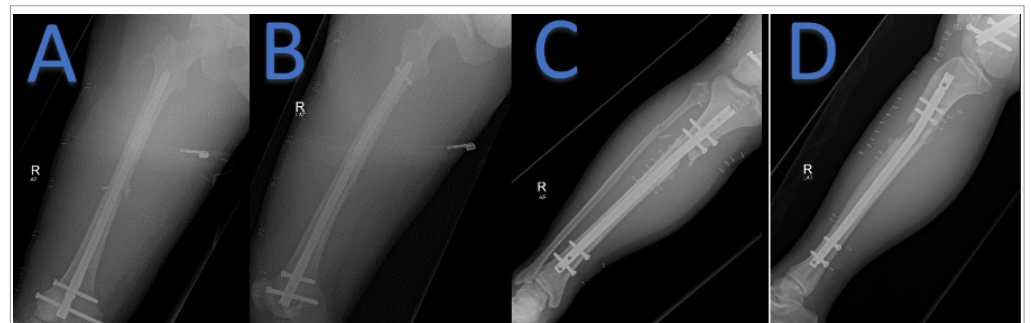
Figure 4. Radiograph of right femur anteroposterior (A) and lateral view (B) postoperatively. Radiograph of right Tibia/Fibula anteroposterior (C) and lateral view (D) postoperatively

patient presented within 12 hours followed by retrograde interlocking femoral nail and antegrade interlocking nail tibia after seven days (Figure 4). This was complicated by surgical site infection (SSI), which was treated with culture-sensitive antibiotics after wound debridement. The patient was discharged 1-month postoperatively after the bacterial cultures were negative and the course of antibiotics was completed.

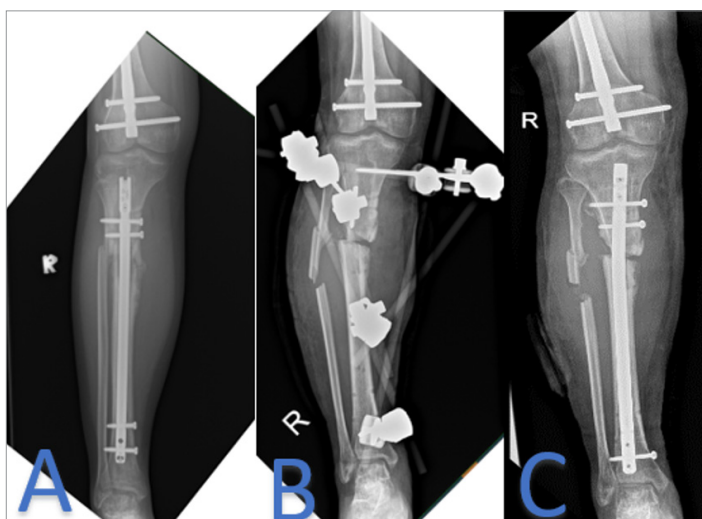
Figure 5. Radiograph of right Tibia/Fibula AP view 6 months post trauma. Figure 5B: Radiograph of right Tibia/Fibula AP view 7 months post trauma. Figure 5C: Radiograph of right Tibia/Fibula AP view 9 months post trauma

presented with a septic nonunion with discharge from the surgical site. On the radiograph, there was the migration of the tibial Interlocking nail proximally with a delayed union (*Figure 5*). We proceeded with the removal of tibial implant and fibulectomy with acute docking delta external fixation of the leg (*Figure 5B*). Intraoperatively we noted a sinus communicating with the fracture, which is suggestive of osteomyelitis of the right tibia. The patient was given six weeks of antibiotics and discharged with a shoe raise of 4cm due to Limb Length discrepancy. At two months post-external fixation it was removed, and we put an antibiofilm coated implant (Orthosyn) (*Figure 5C*). Intraoperatively culture was Methicillin-resistant *Staphylococcus aureus* (MRSA), and he was started on a further six weeks of antibiotics.

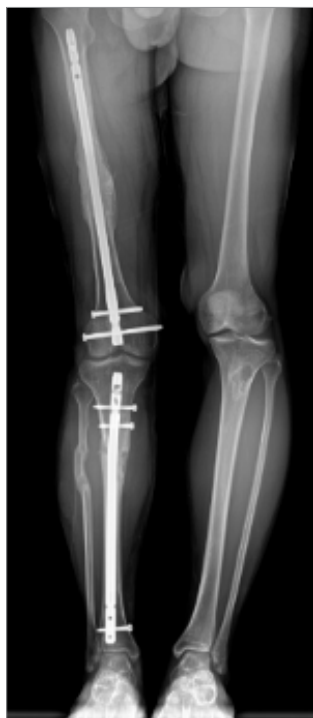
Figure 6. Standing scanogram one year six months post-trauma.

After one year postoperatively he was able to fully bear weight with no complications with a range of motion of the knee 0 to 130 degrees (*Figure 6*). At two years follow up he was ambulating independently with no signs of infection.

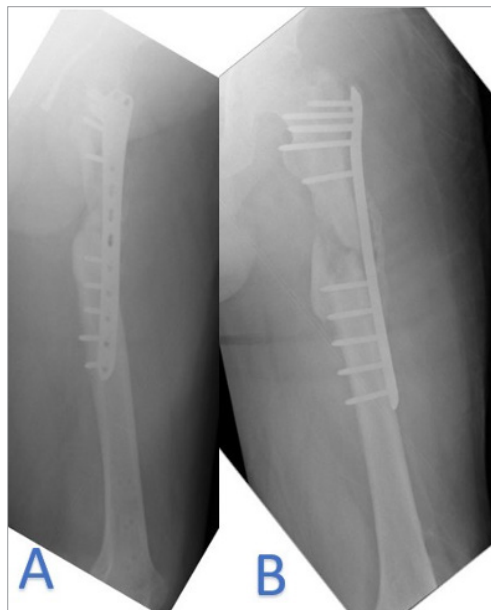
Figure 7. Radiograph of left hip anteroposterior (A) and lateral view (B) post-proximal femur plating

fibrous nonunion of the fracture and hip pain post dynamization procedure, the implant was removed and a 9-hole proximal femur Locking plate with bone graft was inserted (**Figure 7**).

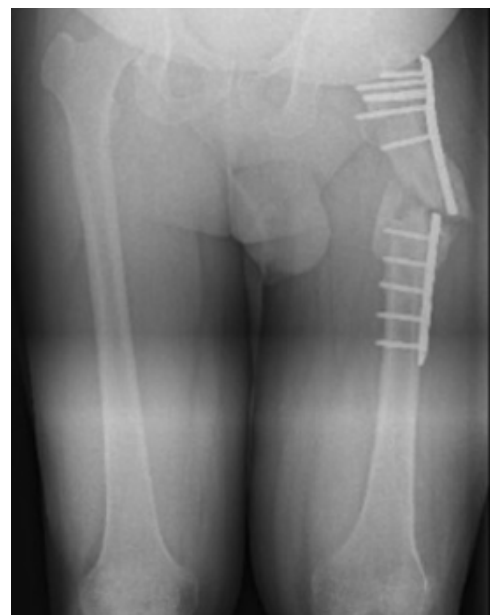
Figure 8. Scanogram post trauma with broken plate.

plate with loosening of all screws (Figure 8), which was removed, and subsequent cultures were sent followed by the insertion of an antibiofilm coated implant (Figure 9A).

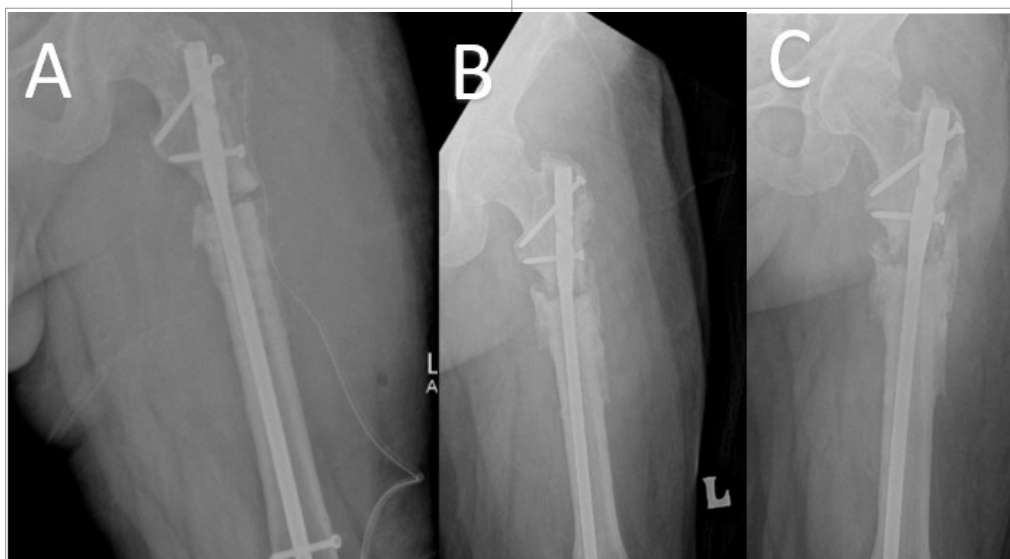
Figure 9. Radiograph of left femur anteroposterior view postoperative with antibiotic coated implant (A). Radiograph of left femur anteroposterior view three years postoperative with antibiotic coated implant (B) and four years postoperative with antibiotic coated implant (C)

Postoperatively he had an apparent shortening of the left lower limb by 5cm with no pain. After four months postoperatively, he was able to walk with crutches with shoe raise. He had a delayed union of the left femur. He can ambulate with minimum support four years postoperatively with no signs of infection (Figure 9C).
